The Impact from the Hygiene Operator on Composite Restorations: Part I

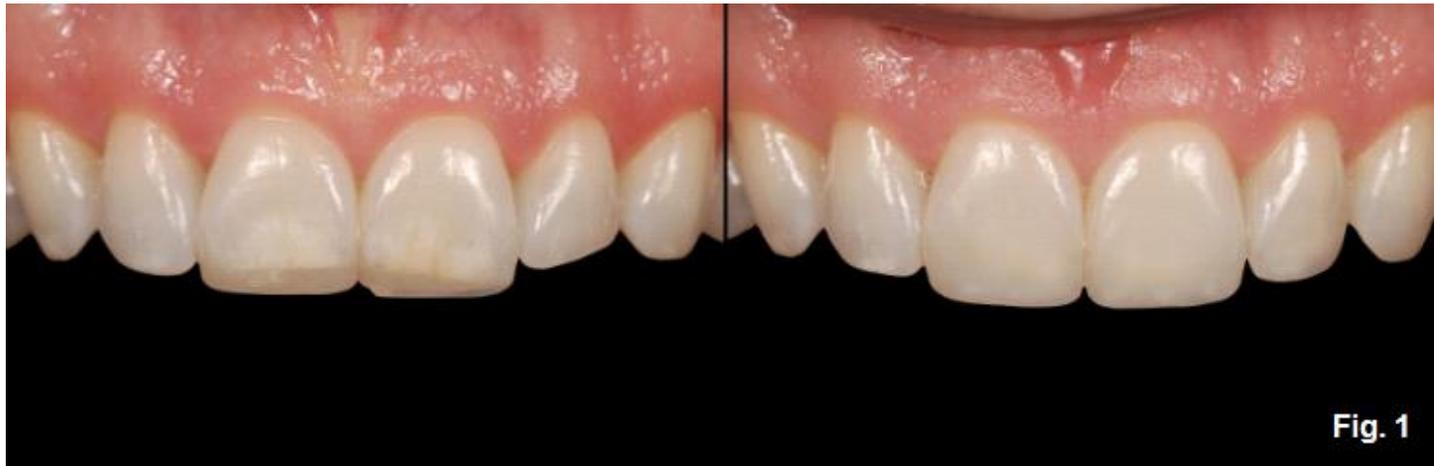
As clinicians, we spend a considerable amount of time placing composite restorations that strive to re-create a natural surface texture and polish. (Fig. 1) We know from the literature that numerous factors have the potential to degrade the composite surface over time, but have you ever stopped to think about how the things we do in our own practices affect the composite surface – specifically in the hygiene operator? ¹
